## Memorandum

Subject: Geotechnical Consultation for Agate Beach

**Project:** Newport Transportation System Plan Update

Project No.: 2191027-103

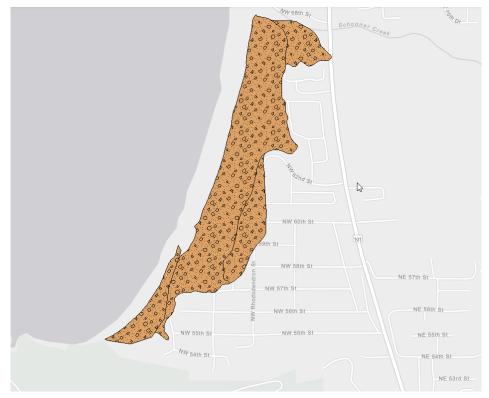
Figure 1. Landslide Hazard Map for Agate Beach (DOGAMI, 2020a).

The geotechnical challenges in Agate Beach include mapped landslide and coastal erosional hazards that will prohibit development of new transportation projects adjacent to the ocean bluff along the west margin of the neighborhood. Figure 1 (attached) shows the current landslide hazard map for Agate Beach obtained from the DOGAMI SLIDO 4.1 website (DOGAMI, 2020a). Figure 2 (attached) shows the current coastal erosion hazard map for Agate Beach obtained from the DOGAMI HAZVU website (DOGAMI, 2020b). Transportation improvements will need to be setback from existing bluffs or areas of mapped landslide topography and focus on the relatively flat terrain in the neighborhood to the east. The setback from the bluff may be assumed to coincide with the eastern extent of the landslide terrain shown on Figure 1, which also approximately corresponds to eastern boundary of the high coastal erosion hazard area.

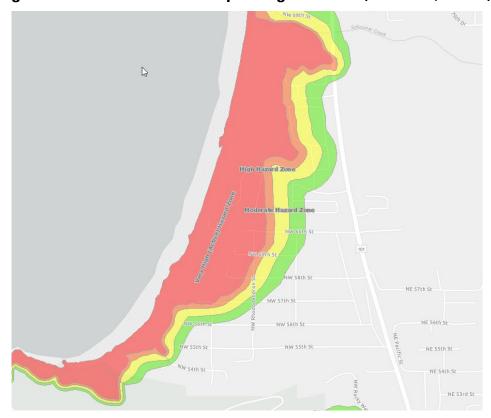
Figure 2. Coastal Erosion Hazard Map for Agate Beach (DOGAMI, 2020b).
